Docket No. 217 – Development and Management Plan Inspection

Date: February 2, 2006

Location: 345kV Underground Route

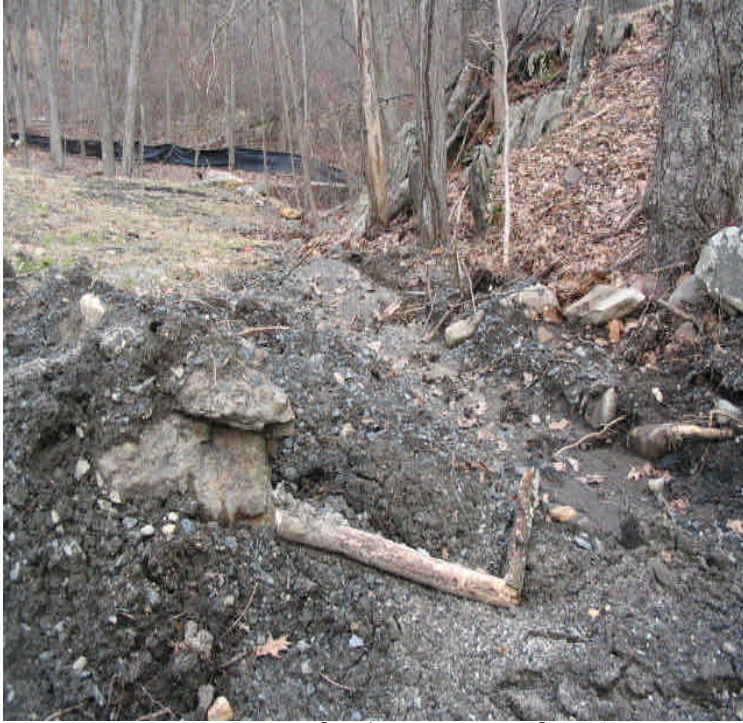
Umpawaug Rd.	<p>-Active trenching is not occurring at this time. A stockpile and small storage yard remain in place. 2/2/06</p> <p>- A gully continues to form down the recently constructed slope near #79 and deposits</p>	<p>-Continue to monitor controls. The area below the slope could use some additional restoration where equipment had been moving. 2/2/06</p> <p>- Remember to restore this area when feasible 2/2/06</p> <p>- Run-off is from the roadway but the sediment is from the un-stabilized slope. Place</p>

3345kV (Umpawaug Rd. & Georgetown Deli): Photo on the left shows the area near #79 Umpawaug where street runoff eroded a gully through the recently constructed bank to the stream. Photo on the right is of the restored stream bank with erosion control matting at the Georgetown Deli. 2/2/06

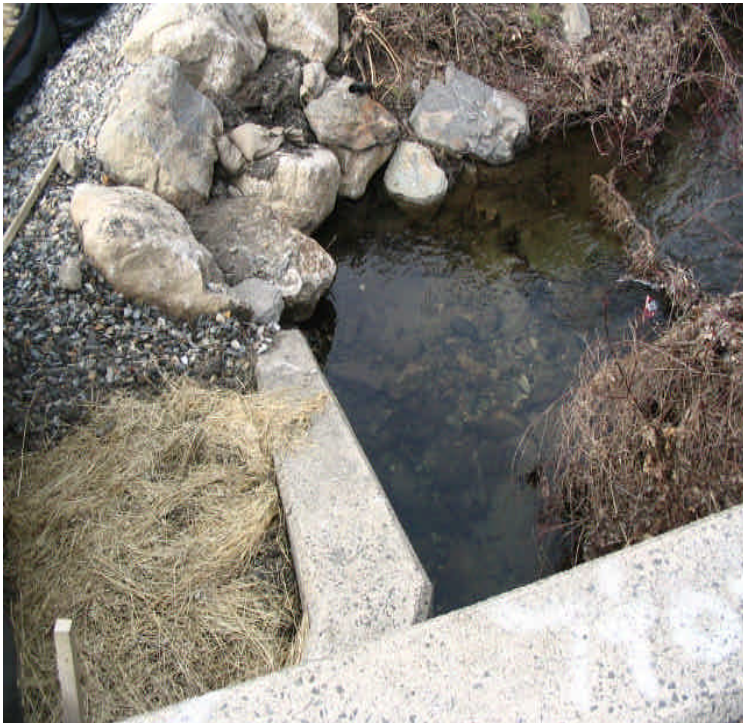
Photo on the left shows the stream running clear at the receiving pit side which is also restored at this time. Photo on the right shows a view of the recently restored intersection south of the jack and bore where the trench was completed. 2/2/06

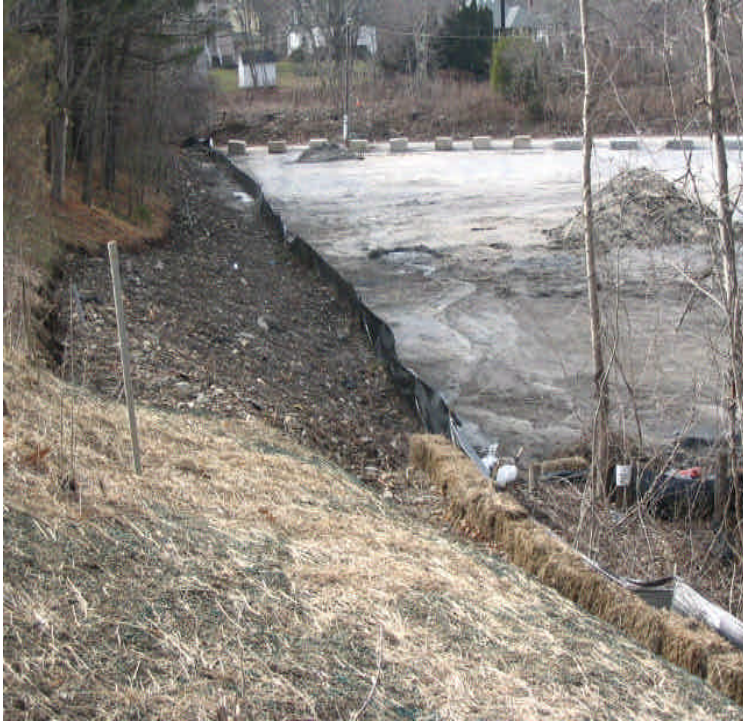
345kV (Rt. 107) Photo on the left shows the erosion controls in place along the redevelopment parcel near the Norwalk River. Photo on the right shows the Rt. 107 & 7 intersection where equipment access created ruts and sediment towards the street. Restoration is needed. 2/2/06

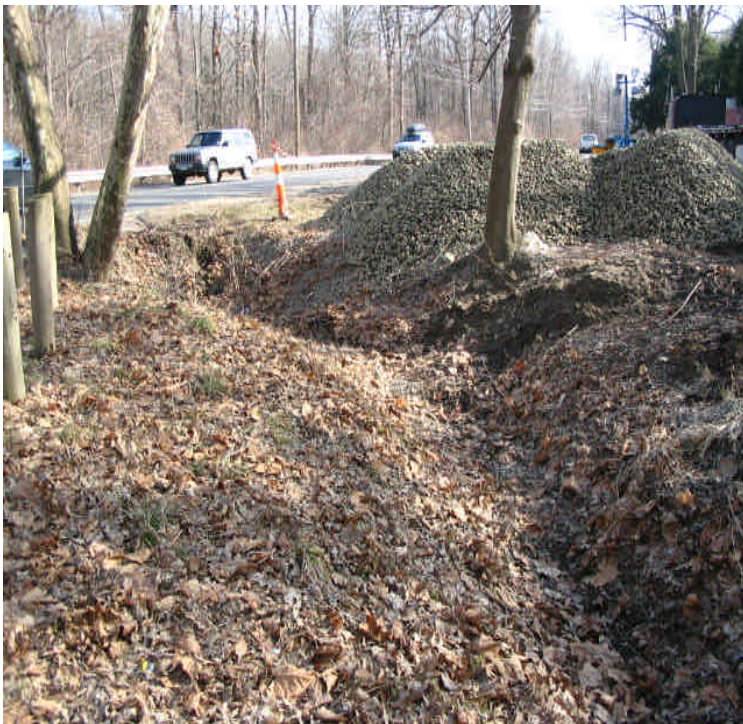
345kV (Rt. 7 & HDD): Photo on the left is a view of the Racquet club where active work was occurring. This area is a stormwater swale with an inlet that needs some protective measures. Photo on the right shows an overview of the work site and basin at the HDD. 2/2/06

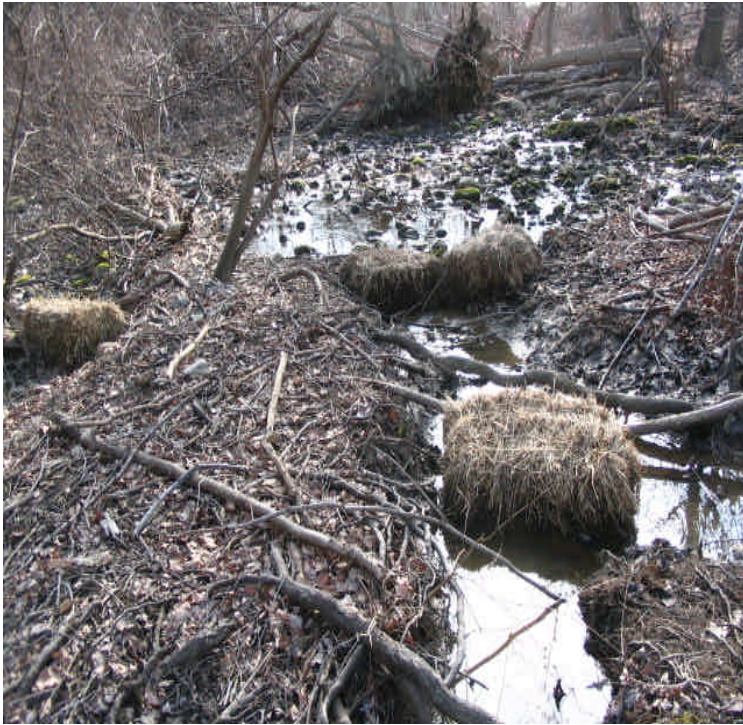
345kv (HDD): Photo on the left shows some of the check dams and controls in the wetlands beyond the basin. There is some minor sedimentation in some areas, but most of the wetland is in good shape. Photo on the right shows the drilling muds returning from the bore to the basin. 2/2

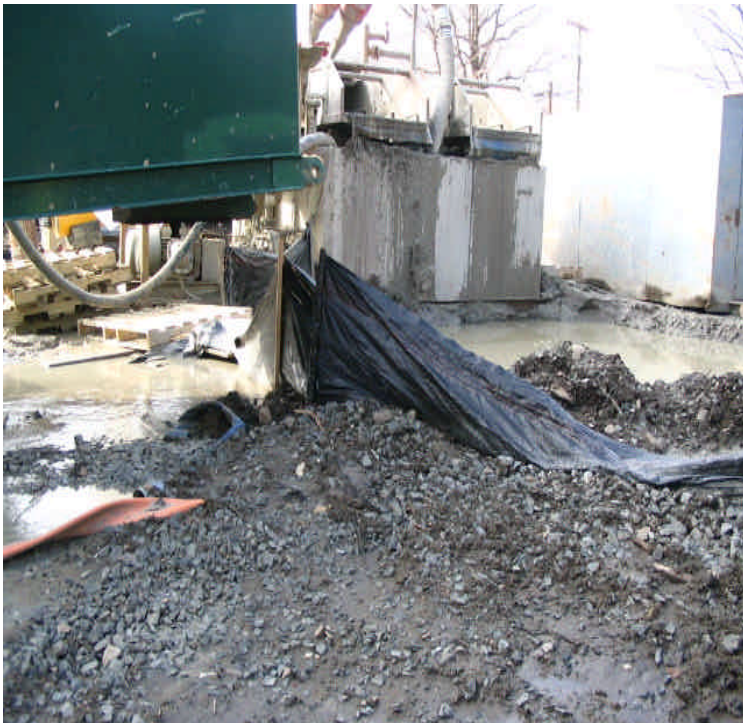
Photo on the left shows some turbid water below the baker tank. A slight depression here keeps some of the water in place but the remainder flows beyond the fence. Photo on the right shows the water eventually flowing back to the basin. 2/2/06

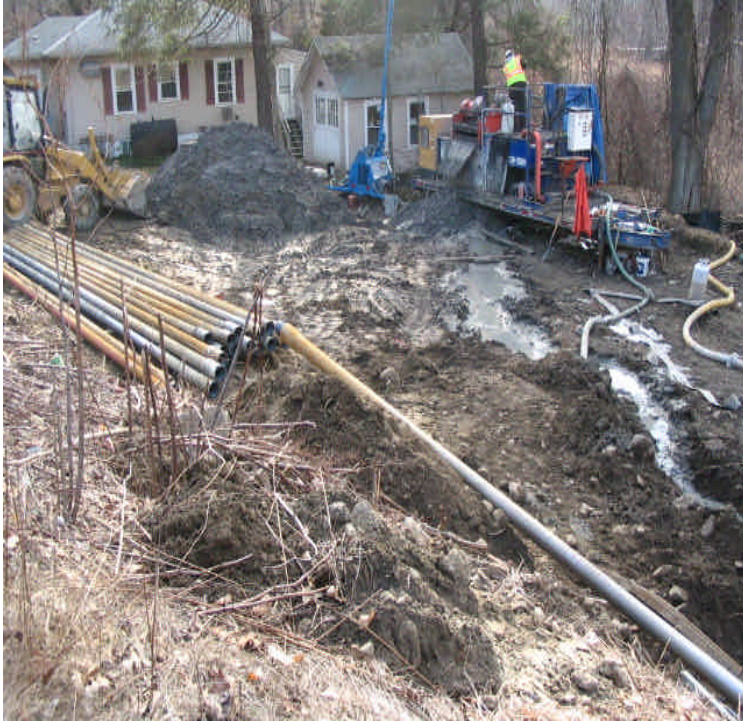
345kV (HDD return pit): Photo on the left is a view of the HDD return site where the drill had come through and muds were being pumped and returned. Erosion controls were well in place. Photo on the right shows the muds within the trench. 2/2/06

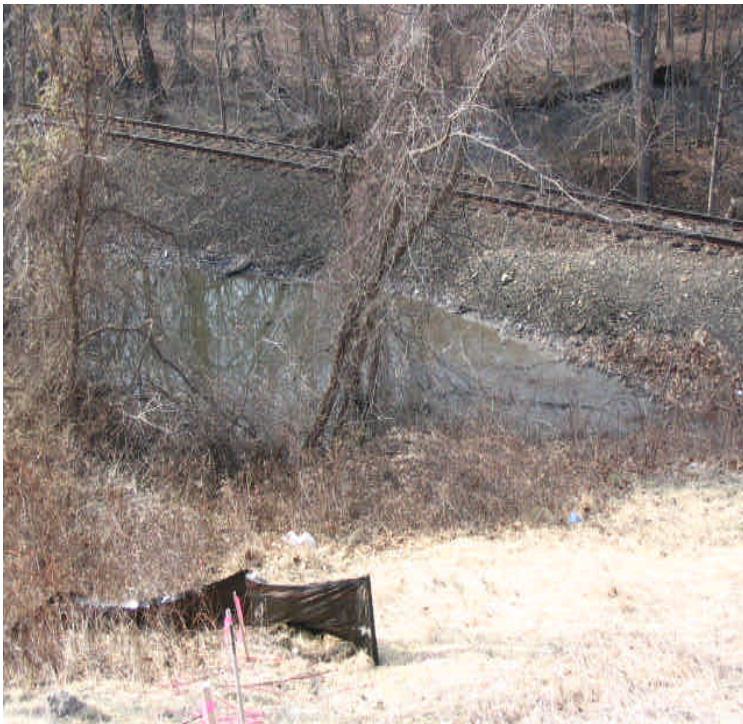
345kV (Rt. 7): Photo on the left is a view of an area of ponded water downgradient of the return pit. Water was somewhat turbid but it is unclear whether this is somehow a result of the muds or unrelated. The river continues to remain unaffected. Photo on the right shows hydroseeding as restoration along Rt.7. 2/2/06
